**FORD:**

2005-2008 Mustang

Some 2005-2008 Mustang vehicles may exhibit a difficult to diagnose water leak in the front floor area. This may be caused by loose grommets and/or sealer skips around the cowl area, loose A-pillar window weather stripping retainer, misaligned body harness grommet through the firewall, or misaligned body harness grommet from the passenger door.

## TSB 07-14-6 (Continued)

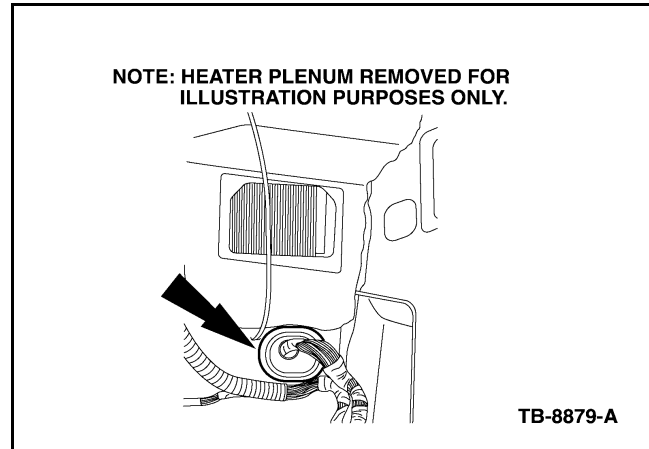
Figure 3 - Article 07-14-6

5. Check the main body wiring harness grommet for proper seating or mis-positioning into the bulkhead on the driver/passenger side.
  - a. Reposition the grommet into the bulkhead making sure the grommet is fully seated and sealed. If there is any aftermarket wiring installed through the grommet, reroute and seal as necessary. (Figure 3)

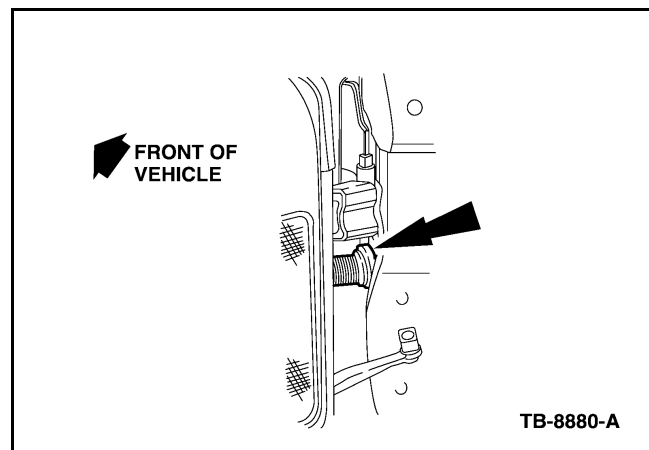
Figure 4 - Article 07-14-6

6. Verify that the door to the A-pillar wiring harness grommet is fully seated into the A-pillar.
  - a. To ensure proper sealing around the wiring harness grommet, apply a small amount of TA-2 Motorcraft® Repair Urethane Adhesive/Seam Sealer and reinstall the grommet into the A-pillar. (Figure 4)

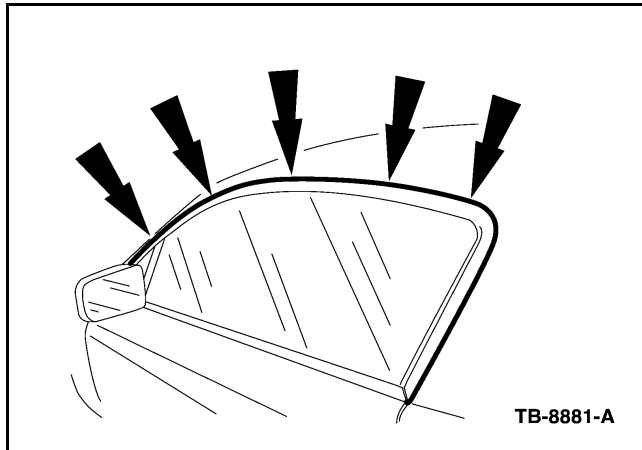
Figure 5 - Article 07-14-6

7. Inspect the foam seal of the window weatherstrip retainer at the A-pillar. Tears in the foam seal may allow water to enter the vehicle between the window weatherstrip retainer and the A-pillar, and travel inside the interior A-pillar trim molding into the dash kick panel area.
  - a. Replace the window weatherstrip retainer, if damaged.
  - b. Reassemble other trim as required. (Figure 5)
