**FORD:**

2005-2009 Mustang

This article supersedes TSB **07-14-6** to update the model years, part list and service procedure.

## TSB 08-26-7 (Continued)

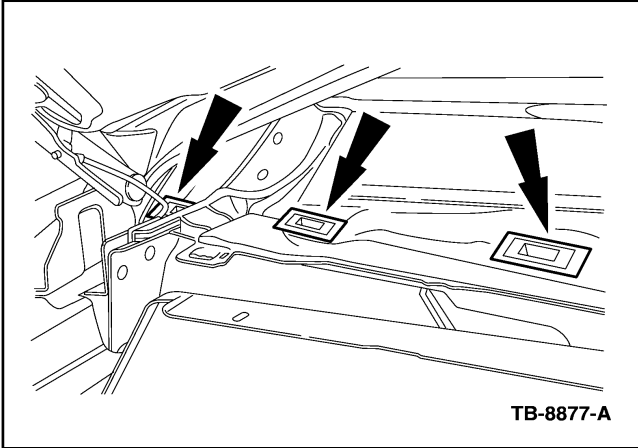
Figure 1 - Article 08-26-7

1. Verify that the plastic cowl panel grill is evenly seated against the windshield and not warped. If warped, replace with current service stock.
2. Remove the cowl panel grill. Refer to Workshop Manual (WSM), Section 501-02, and inspect for proper cowl panel mount grommet installation and pinch weld sealing. Water may enter the cowl channel, through the cowl panel grommets / seals or forward pinch weld, potentially causing a sloshing sound and/or water leaking down the dash kick panel area. If there is standing water in the cowl channel, remove by siphoning through a cowl panel mount grommet hole. (Figures 7-8 - end of article)
3. Verify that the ten (10) cowl panel mount grommets and seals are installed and sealing tightly to the vehicle. If any are missing, or the seals are damaged, replace as necessary. (Figure 1)

- a. Remove old cowl grommets and clean entire cowl surface with a suitable wax and grease remover. If silicone and/or seam sealer was used to seal grommets, ensure all sealer is removed before installing new grommets.
- b. With surface clean and prepped, snap the hot melt cowl grommet into cowl panel.
- c. Using a suitable heat gun, heat the hot melt cowl grommet until the hot melt material begins to squeeze out from under the plastic grommet. Do not over heat the grommet because deformation of the plastic grommet may occur.
- d. After heating the grommets, a light amount of pressure may be applied to the outer perimeter of the grommet to help sealing.
- e. Do not over heat around windshield or fender edges or damage may result.

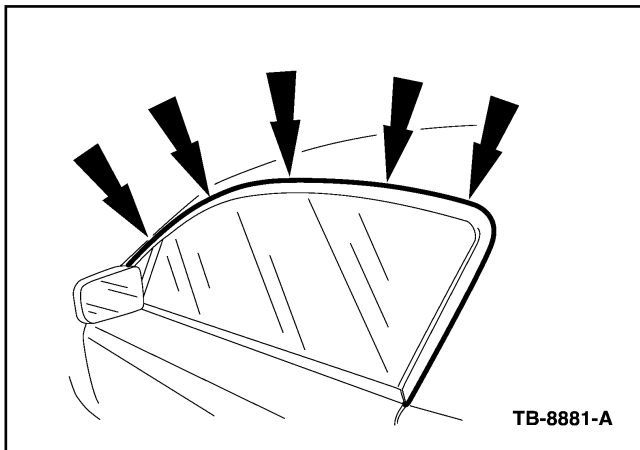
Figure 5 - Article 08-26-7

7. Remove and inspect the foam seal of window weatherstrip retainer at the A-pillar. Tears in the foam seal may allow water to enter the vehicle, between window weatherstrip retainer and the A-Pillar, and travel inside the interior A-Pillar trim molding into the dash kick panel area. (Figure 5)

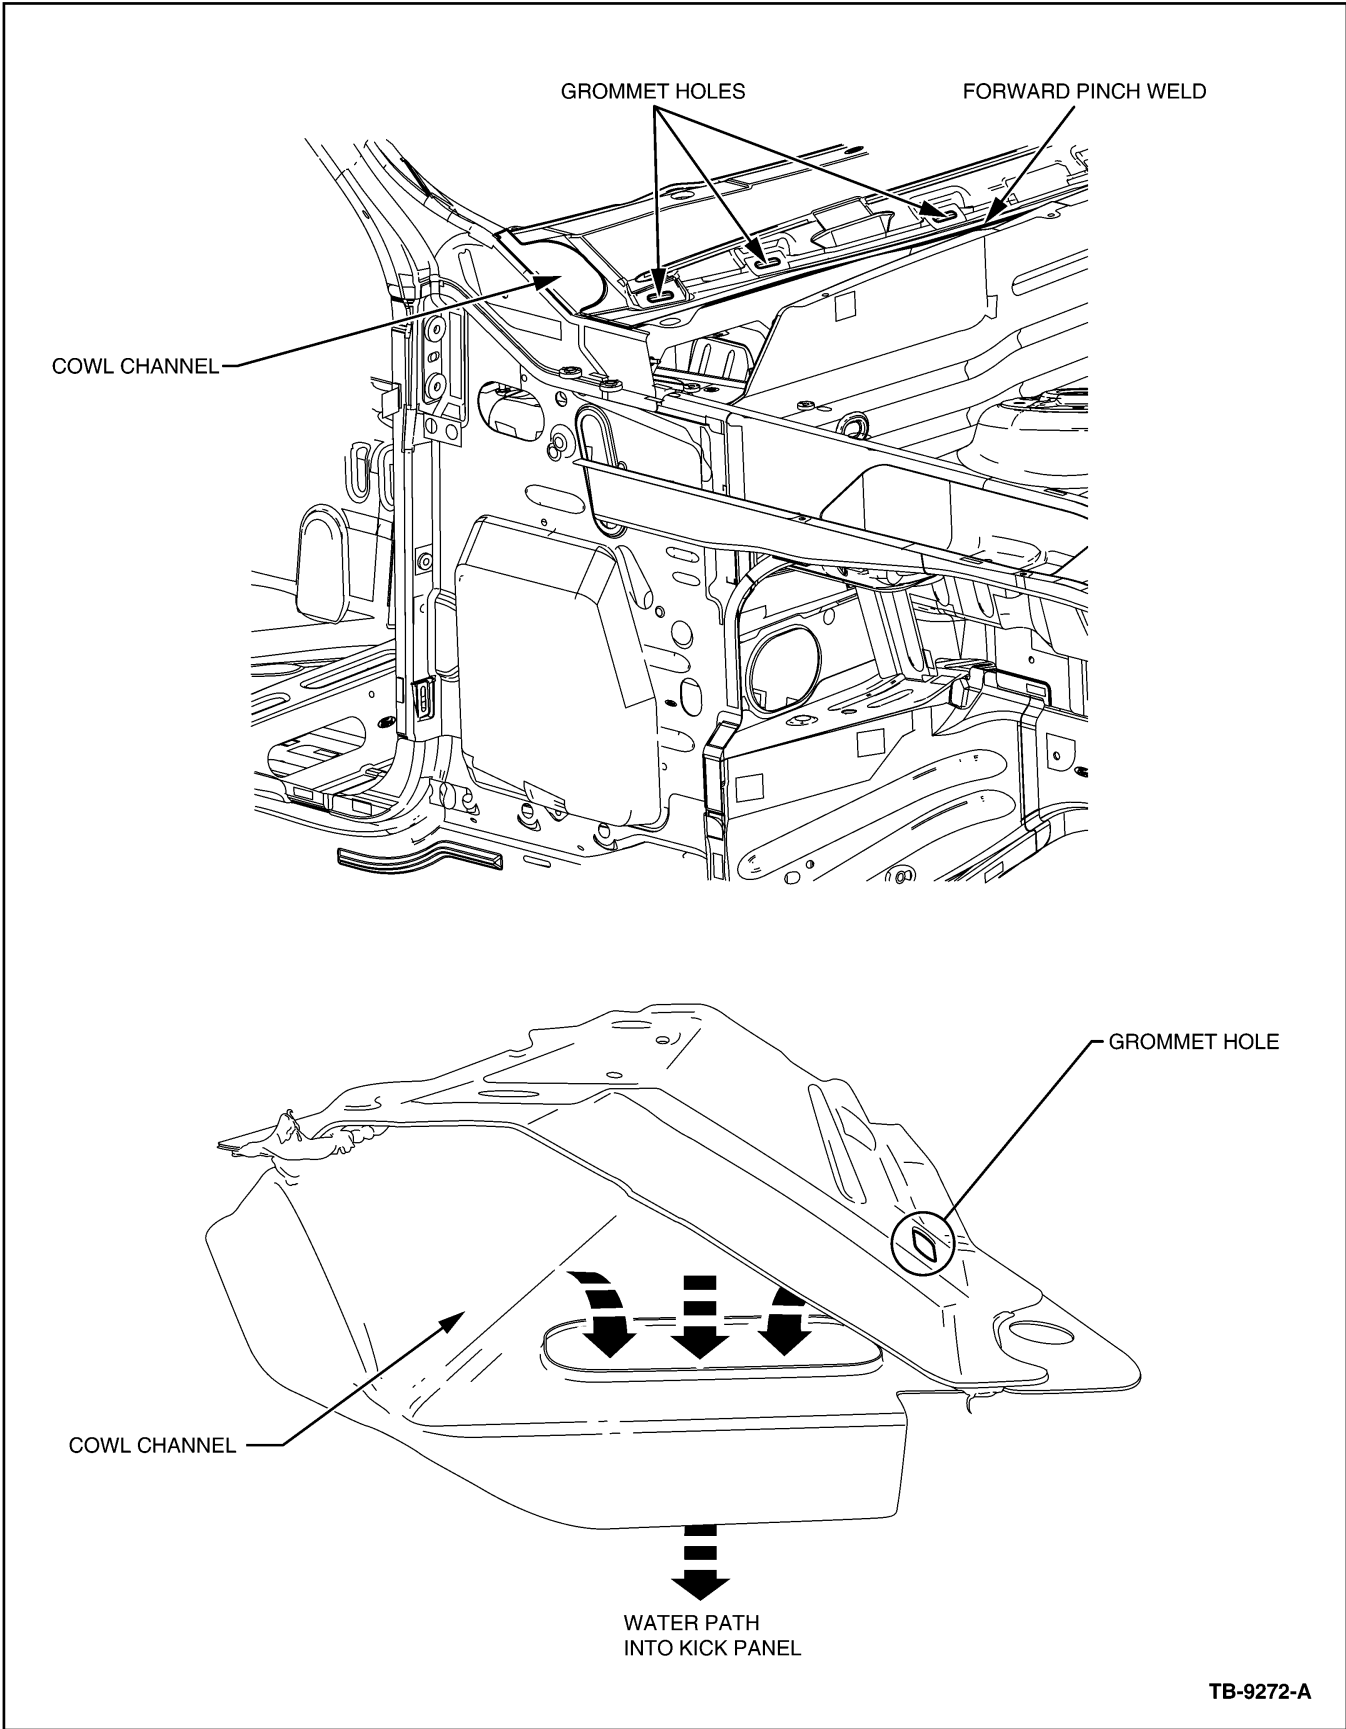
Figure 7 - Article 08-26-7

**WATER PATHS INTO FRONT FLOOR KICK PANEL AREAS**  
(DASH AND DASH INSULATOR REMOVED FOR ILLUSTRATION PURPOSES)
