**FORD:**

2005-2009 Mustang

This article supersedes TSB **07-14-6** to update the model years, part list and service procedure.

## TSB 08-26-7 (Continued)

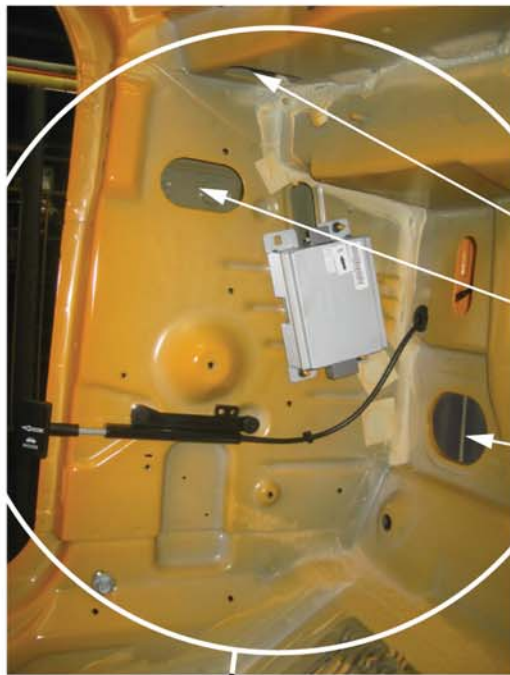
DRIVER SIDE KICK PANEL

Some 2005-2009 Mustang vehicles may exhibit a difficult to diagnose water leak in the front floor area. This may be caused by loose grommets and/or sealer skips around the cowl area, loose A-pillar window weatherstrip retainer, misaligned body harness grommet through the firewall, misaligned body harness grommet from the passenger door.
